Main Lines @ MCBWSD

**MARCH
2016**

**Mt Crested Butte
Water & Sanitation
District**

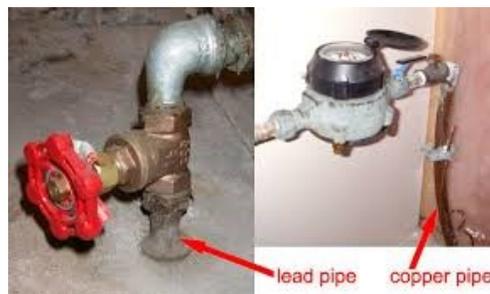
If you are a property owner, there are steps you can take to address potential risks from lead in water. Lead service lines are typically only present in much older homes, but older brass faucets with lead content can be in newer homes. A certified plumber can tell you for sure if you have a lead service line, check for lead solders in your internal pipes and look for fixtures containing lead. There are other steps you can take to protect your family, including purchasing a certified water filter to remove lead, making sure you flush out the lines after a period of stagnation in order to get fresh water that is coming from the main, and avoiding consuming water from the hot water tap, where lead is more likely to be present. Identifying lead pipes should be left to professionals, however below is an example of the appearance of a lead service line vs. a copper line for reference:

Lead does not come from the treatment plants and water mains; it comes from lead service lines running between the water main in the street and the home, and from plumbing inside the home. In our community, we do not believe we have any lead service lines. The practice of installing lead service lines was discontinued prior to the establishment of this community. Lead based solders began being phased out in the early 80's and were banned completely in 1986 by the United States Environmental Protection Agency as an amendment to the Safe Drinking Water Act of 1974. MCBWS D performs lead and copper testing every three years in our service area and test results confirm that levels of lead in customer's homes are well within compliance.

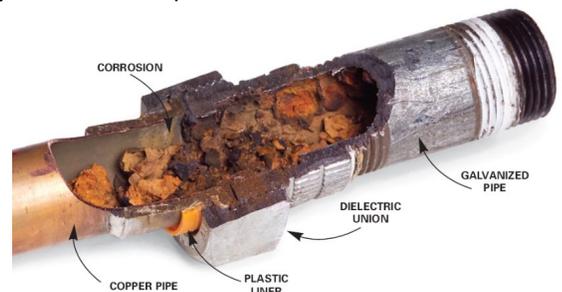
Below is an example of the type of corrosion seen in galvanized pipe:

MCBWS D's Rules and Regulations place ownership of service lines on customers. While we do not believe we have issues related to lead service lines, we do have concerns with existing galvanized service lines. These lines, even with proper fittings, degrade over time and plug up with rust. Many leaks on customer service lines over the years have been attributed to galvanized service lines.

Signs of galvanized service line corrosion include rusty water, particularly upon first turning on a faucet, visible external corrosion and reduced pressure over time. Often when a galvanized pipe is found leaking it is simply repaired and placed back in service, this simply defers the existing problem to a later date. We encourage all customers who believe they may have galvanized service lines to consult a qualified plumber regarding replacing these lines before they fail.
